# The ABCs of Stucco

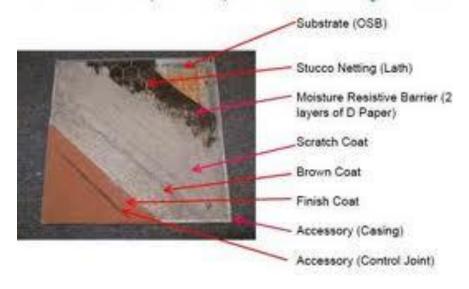
#### Traditional (3 Coat) Stucco Components

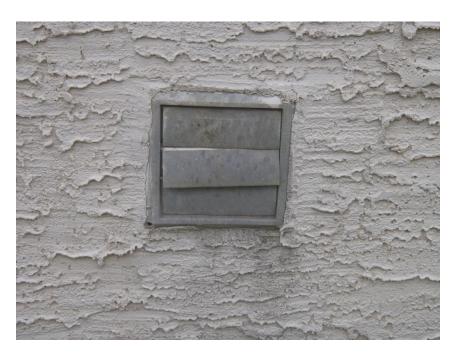
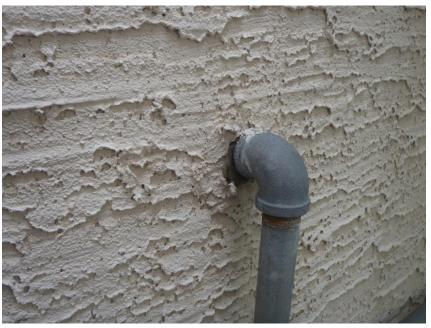
#### Dryer vent. Gas pipe

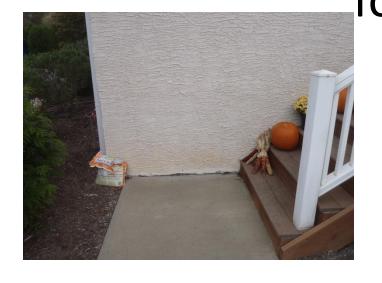
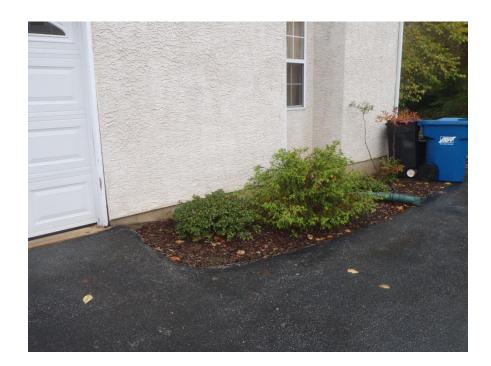
# No weep screed installed at the intersection of house framing and the foundation.

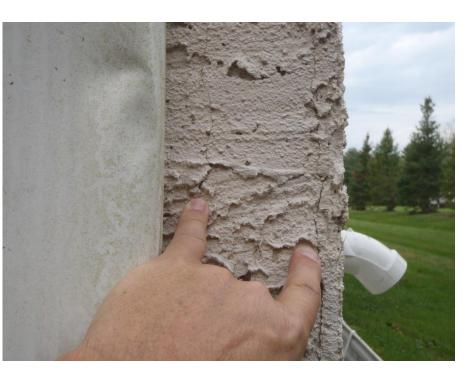
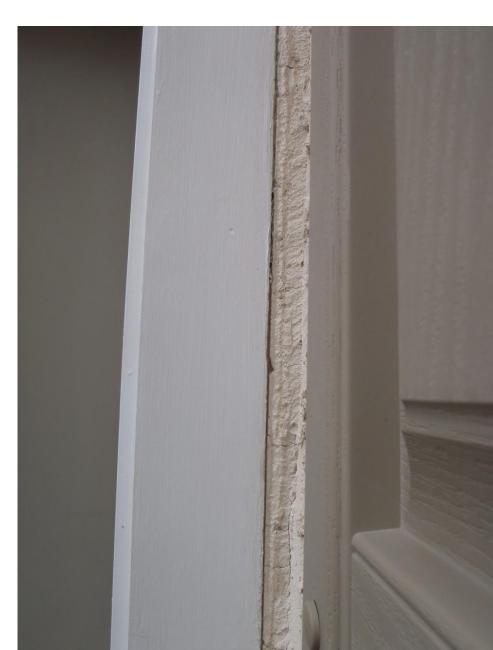
# Developing cracks

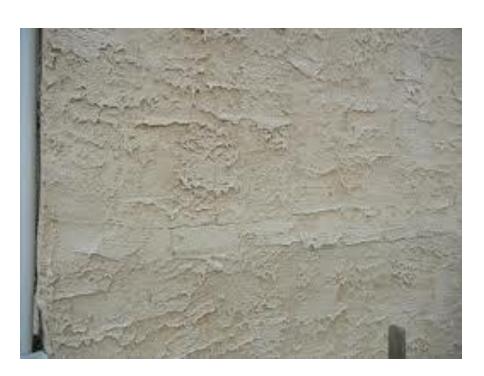
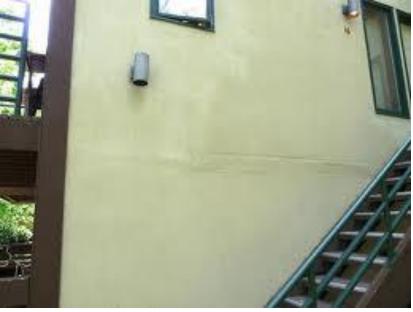
#### Bulges are bad

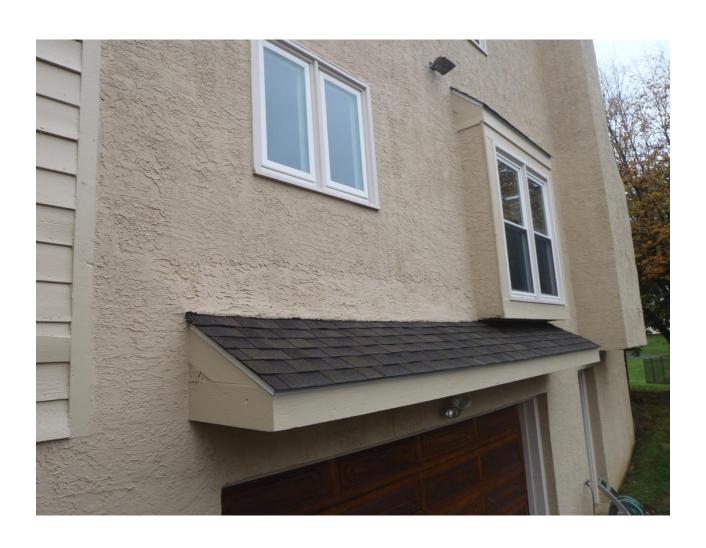
#### Repaired bulge or crack

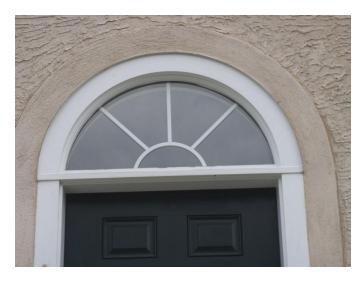
#### Drip cap or the lack there of

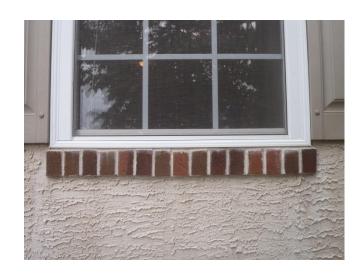
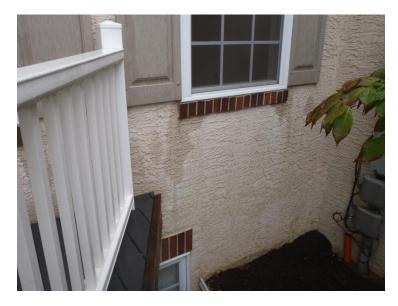
### No caulk gap

No caulk gap at all stucco terminations around windows, doors, utility penetrations and trim.

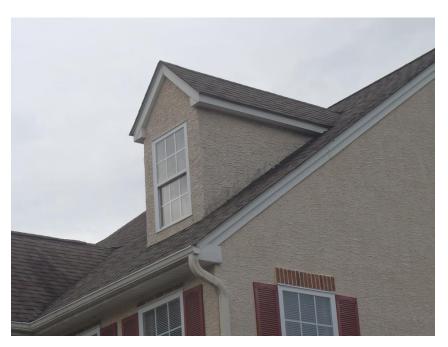
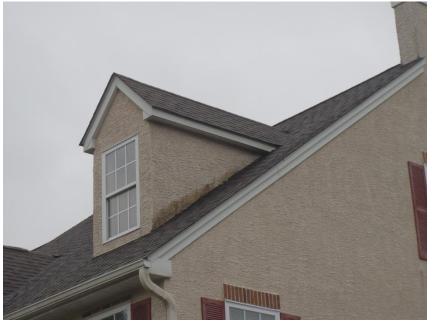
#### Roof contact

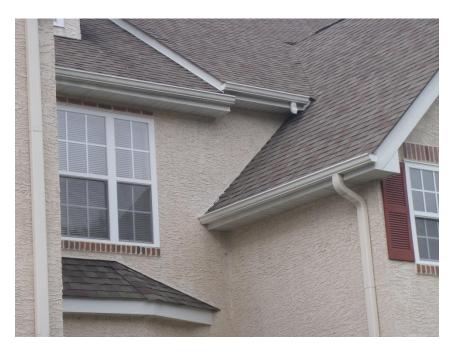
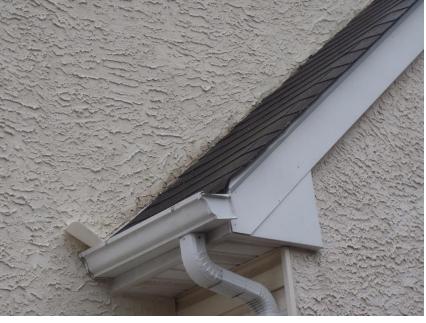
#### Kick outs or the lack there of

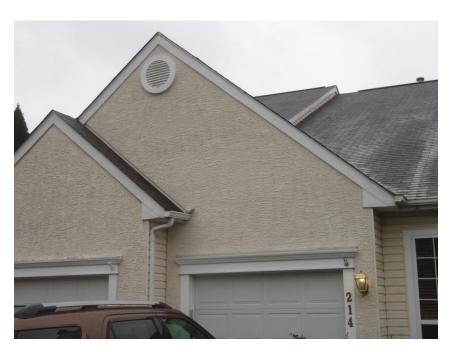
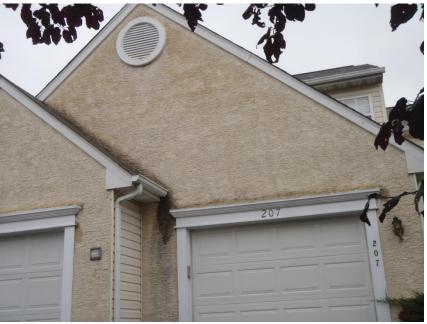
#### Results from no kickouts

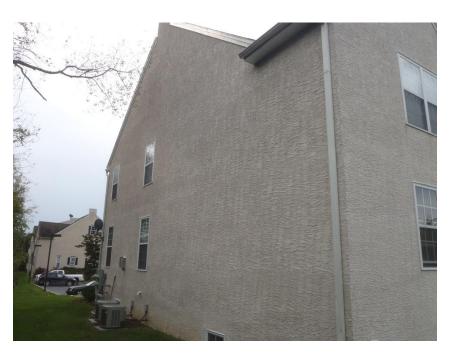
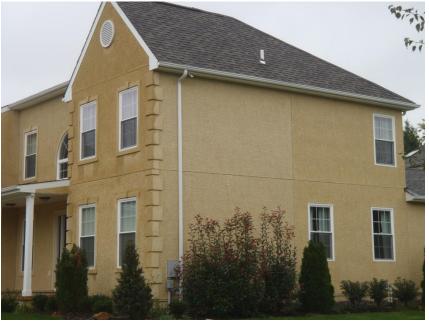
### **Expansion Joints**

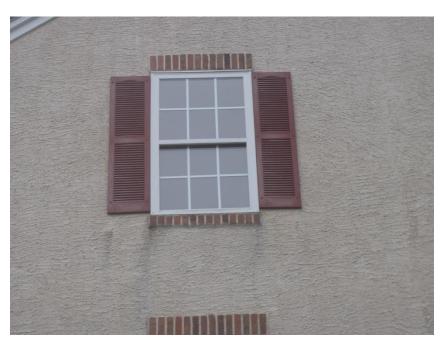
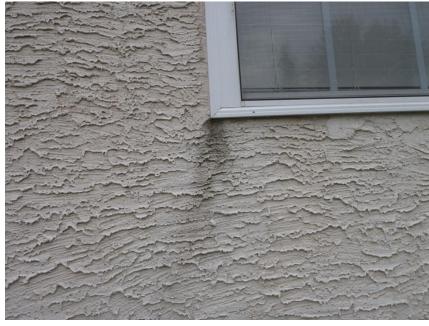
# Black stains indicating water penetration

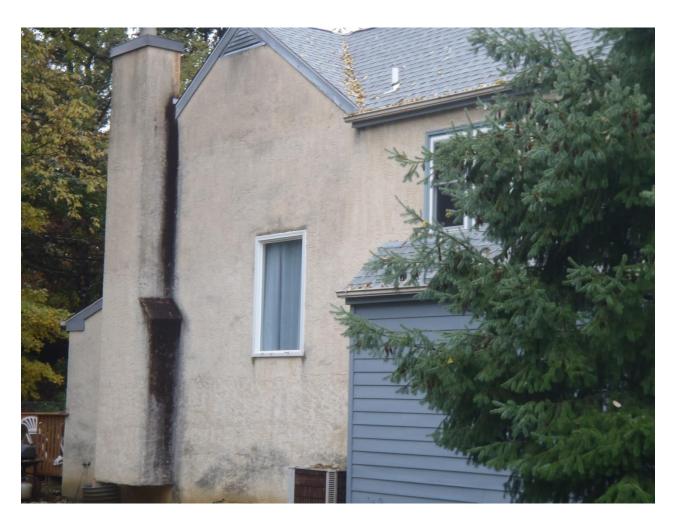
## The larger, more surface area and blacker the more serious

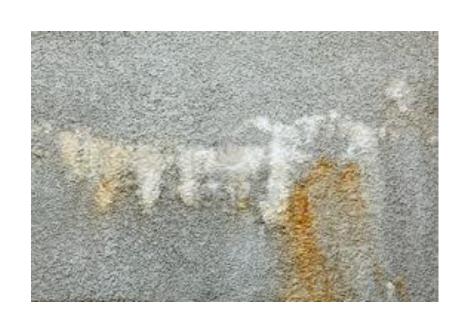
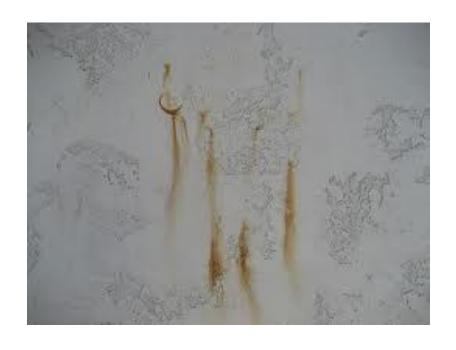
### Rust through stucco

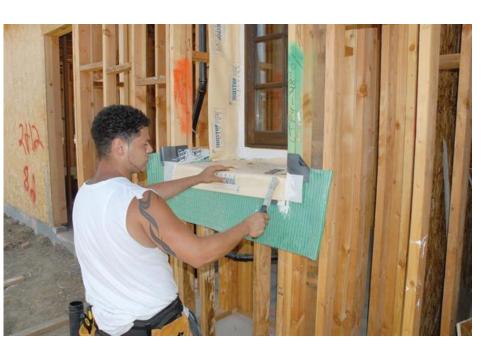
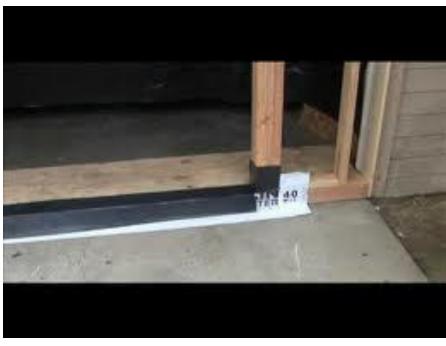
## Inspector could not determine the thickness or see the window flashings.

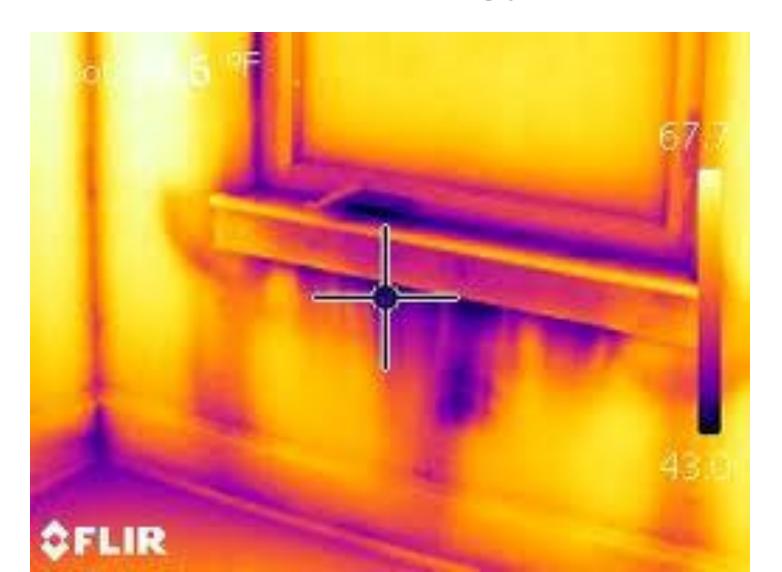
# Flir testing- no holes, infrared technology

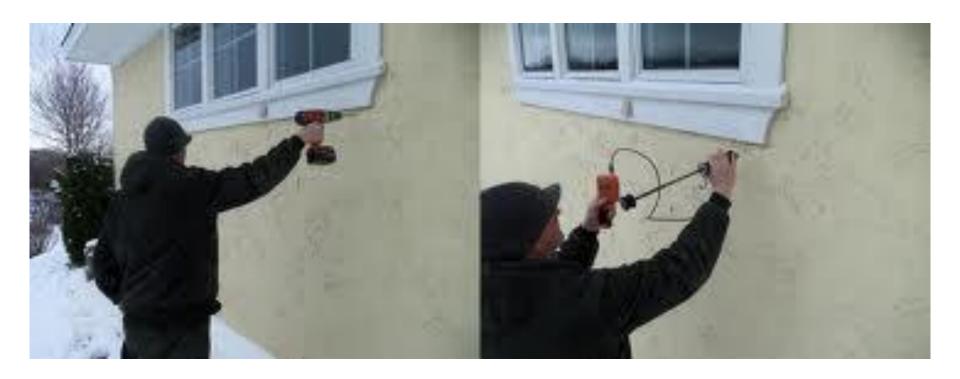
## Intrusive- drilling holes in prescribed locations
